# Energy Audit

December 10, 2014

## Wilton Town Hall & Theatre

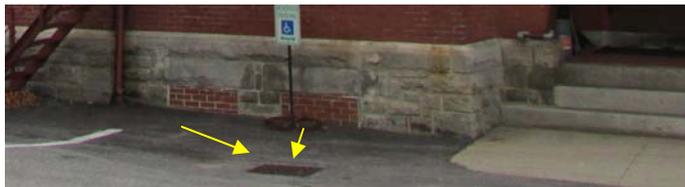
With the exception of the missing downspout section, gravity driven bulk water appears to be effectively managed. However, continued diligence in patching pavement and keeping drains clear is critical for water to be directed away from the building.

5. Assuming the buried drain is not clogged, re-install a down spout on the west side of the building, connecting to the drain.
6. Replace the programmable thermostats in the Selectmen's and Clerk's office, as well as the dial thermostats in the Meeting Room, Assessor's Office and Theatre, with more advanced, easier to operate programmable thermostats. (Example shown to the right). Importantly, program each thermostat for aggressive nighttime and weekend setbacks and timed to return to comfort settings by the time people show up for work. Advanced thermostats can be easily programmed for seven days and can be manually overridden, then automatically return to programed scheduled after one or two hours.

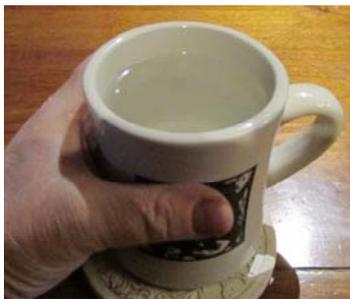
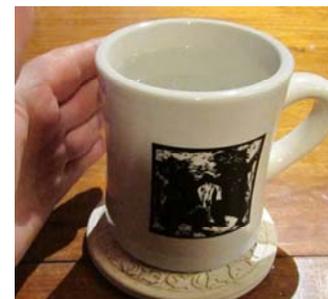
**Conduction** is the process by which heat transfers through direct contact from a warmer surface to a cooler surface. Above, the hot water heated the cup which then heated my hand—very rapidly, I might add! Note that heat will always move to cold, no matter the direction.

**Convection** is the process by which heat is carried in a fluid, such as air or water. In the above illustration, as is often the case in buildings, warmer air rises because it is lighter than surrounding cooler air.

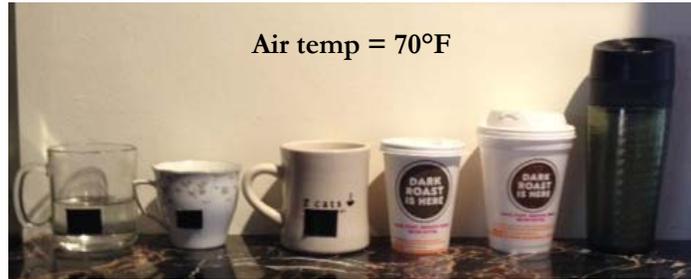
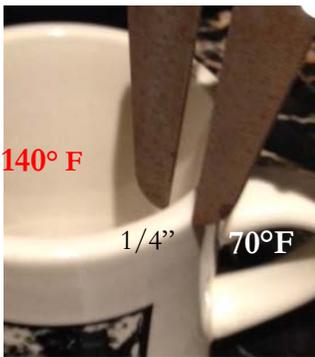
Ceramic conductivity translates mathematically to its “R-Value” or resistance to heat transfer. In this case, for example, R0.4 per inch or R0.1 for the cup—and a delta T of 70°F. (140-70=70). The greater the delta T, the more rapidly heat transfers.

Convective losses will depend on the air above and around each container. The three lidded cups vary due to the lid ‘tightness.’

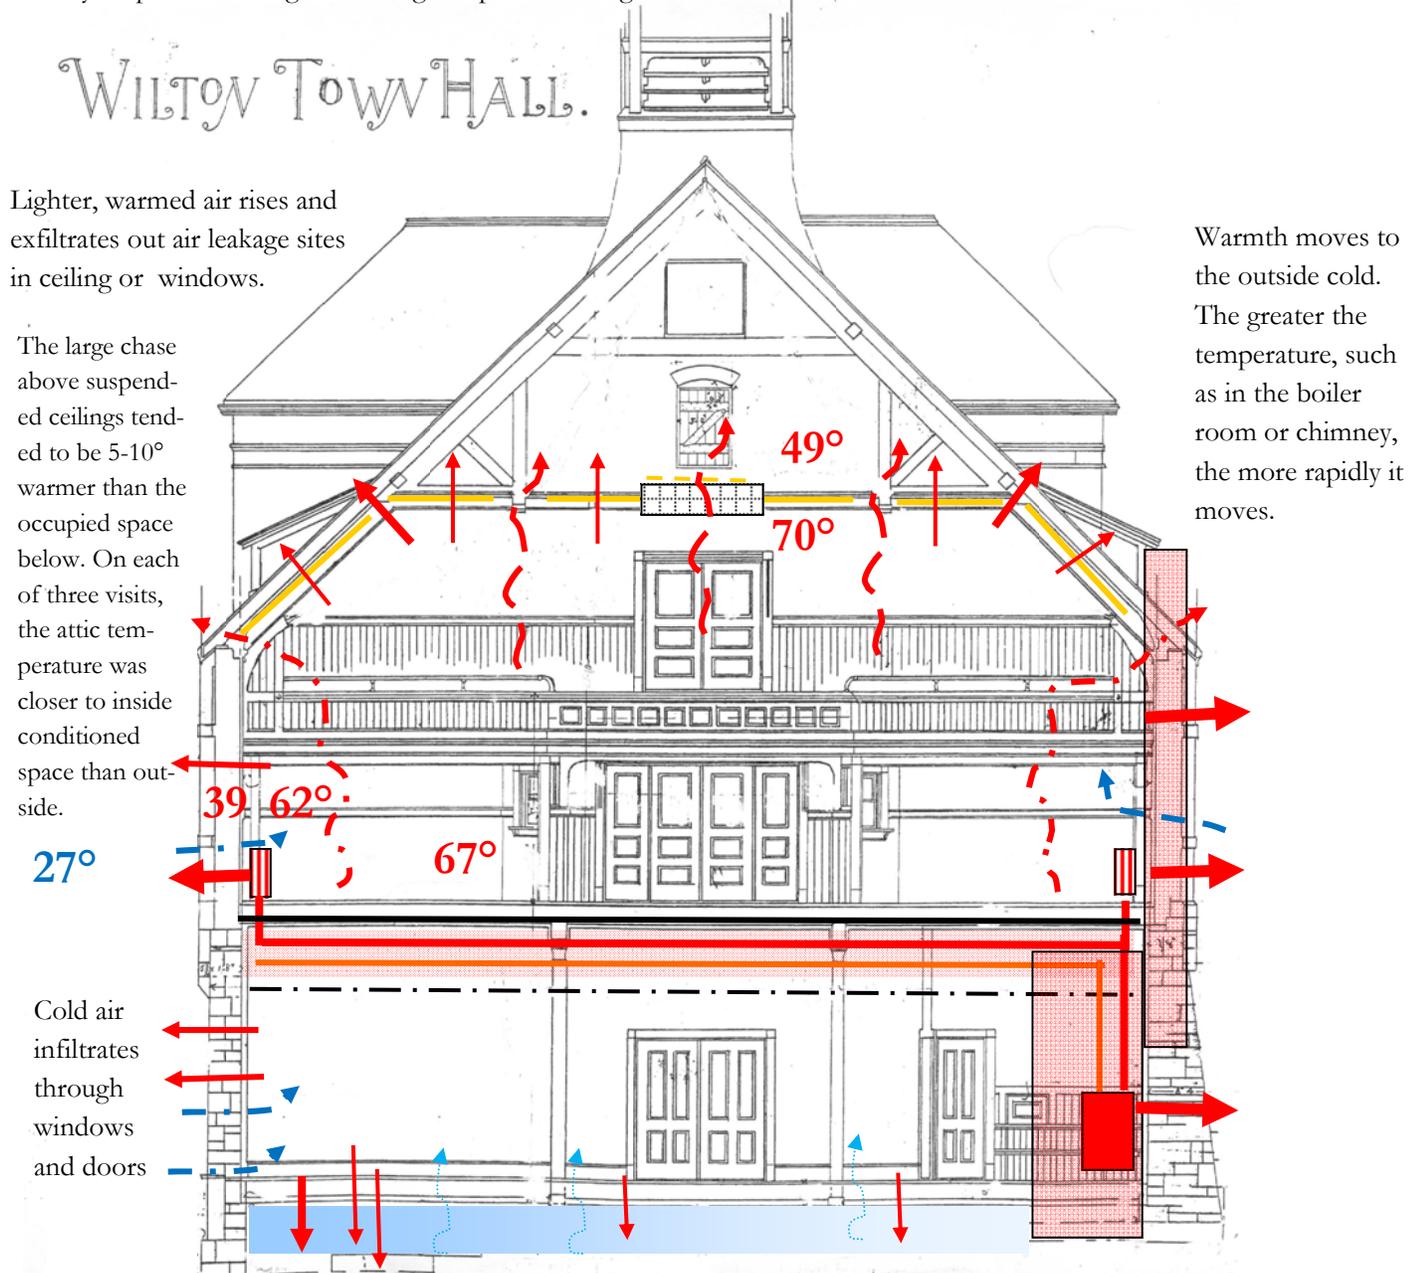
The intention behind this busy graphic is to illustrate some of the more dominant thermodynamic activity in a middle cross section of the building. The crawlspace is connected to outside at the street level and so is cold, meaning that inside heat moves to it through the floor. At the same time, the earth is always at least dampish, so moisture often migrates to dryer conditions above. Cool outside air infiltrates through cracks and gaps at lower parts of the building, then warm and rise to help heat the building but also to exfiltrate to the cold outside. Meanwhile, distributed heat from the steam pipes is most concentrated between the air leaky suspended ceiling and the tighter plaster ceiling under the floor.

The sum result is considerable heat loss to the outside and inefficient distribution and possible discomfort.

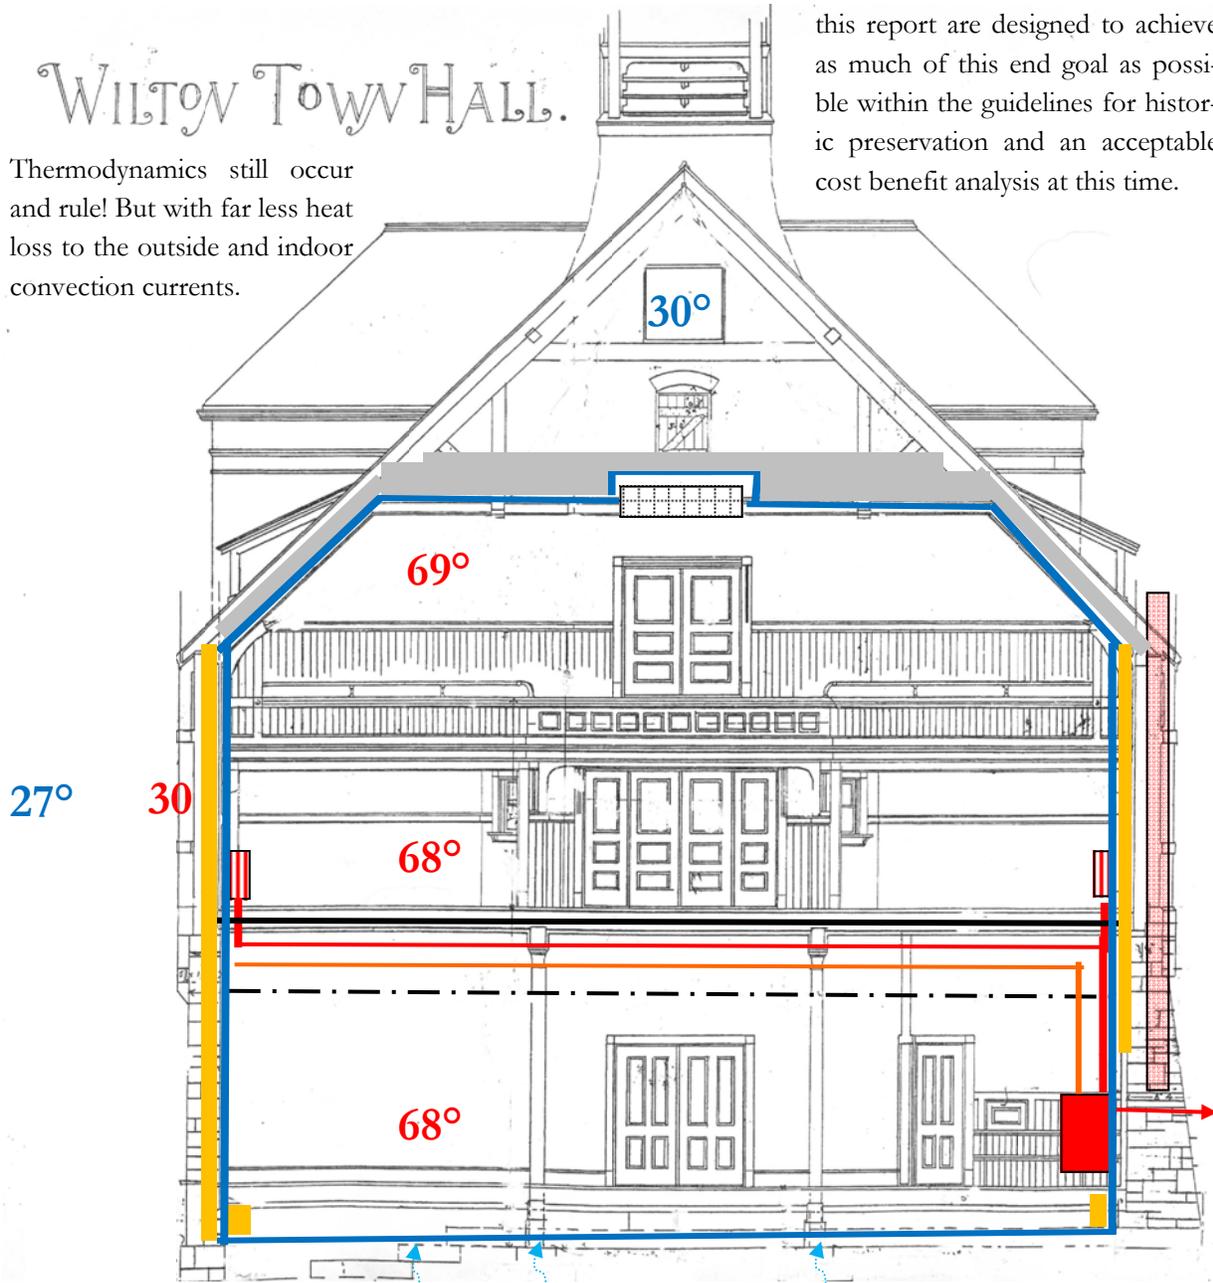
The recommendations included in this report are designed to achieve as much of this end goal as possible within the guidelines for historic preservation and an acceptable cost benefit analysis at this time.

The net result would be a building with dramatically reduced demand for heat, reduced moisture drive through the floor the and responsive zone control for efficient generation and even distribution of supply heat.

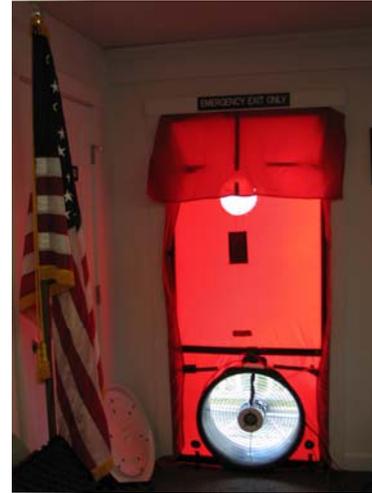
The ‘blower door’ is used to help locate and estimate the amount of air leakage in a building. It consists of an adjustable frame which mounts in an exterior doorway, a nylon “skirt” that is stretched over the frame to stop air except for a hole at the bottom in which a fan is placed. The fan is capable of moving up to about 6,000 cubic feet of air per minute. Plastic tubes are used as “pressure taps” and are attached to the pressure gauge (left) to measure both the amount of air pulled through the fan and the pressure difference between inside and outside.

This equipment can be used for several different diagnostic tests but the most common is for measuring the amount of air which can be pulled through cracks and gaps in the envelope at a standardized pressure (-50 pascals). With the fan running, one can also use a smoke gun or an infra red scanner to locate those cracks and gaps.

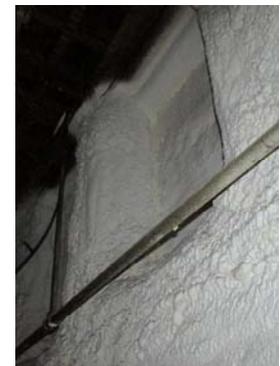
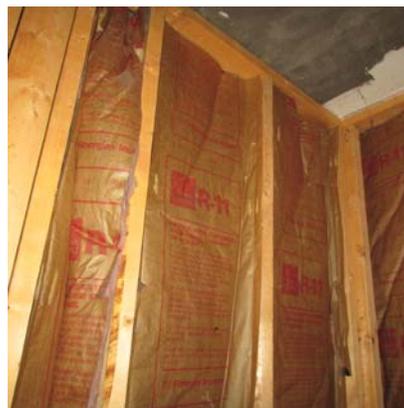
The walls of the Selectman’s Office and restrooms have been framed in with 2x4’s at 16” OC and offset from the granite foundation wall about 7”. Three and a half inch faced (Class II vapor retarder) fiberglass batts (pink) are stapled into the cavities. Note the “R11” stamped on the facing indicates the resistance to heat flow when installed in a chamber in direct contact with an air barrier on all six sides and perfectly lofted. This is rarely accomplished in real life conditions and in this case, the batt is entirely open to the air space before the foundation wall, as well as open to the interior above the suspended ceiling, and not lofted in the cavity—resulting in a greatly reduced thermal performance: effectively between R4 and R6. (photo right)

The only other wall insulation in the building is on the foundation wall behind the file room, kitchen, and women’s WC. Two to three inches of SPF (yellow) directly on the granite from slab to floor decking above - approx. 14 feet. Evidently, this was done as a moisture control strategy with positive results. All other walls in the building appear un-insulated.

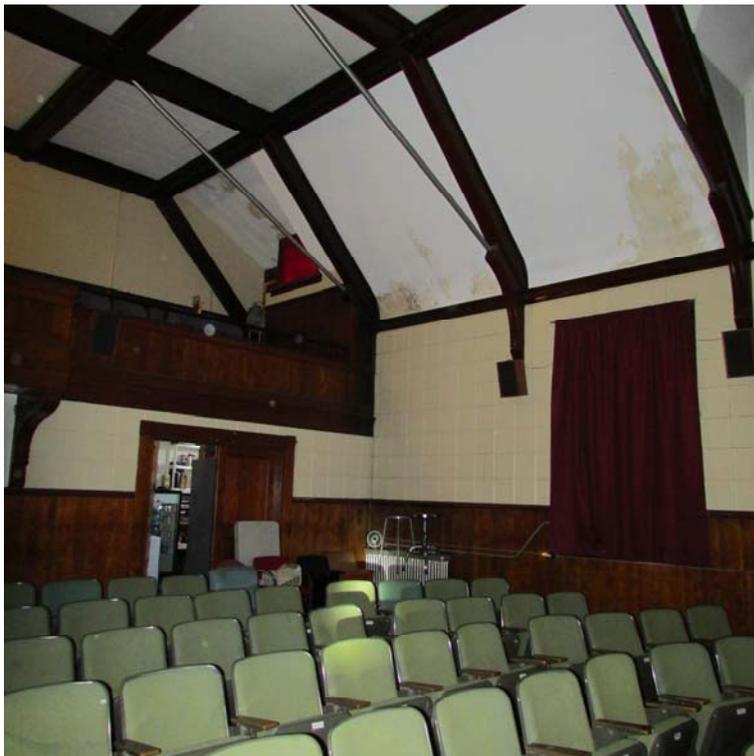
Maple Street Level

The one foot square wall tiles which line cover the walls are presumed to contain asbestos which, if true,

- A) Adds slightly to insulation value and sound buffering
- B) Greatly increases the cost of removing them to insulate and re-surface these walls
- C) Adds another reason to remove and properly dispose them

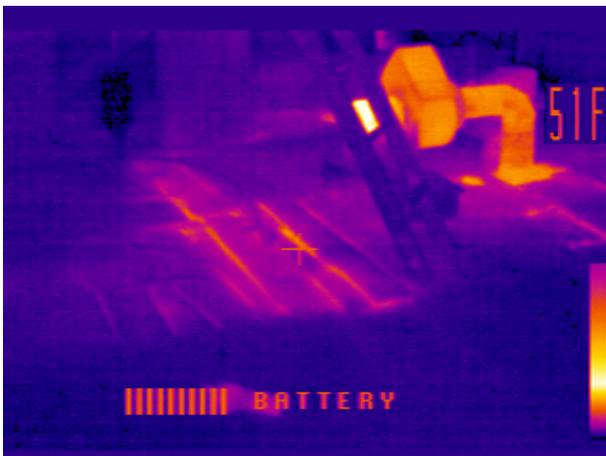
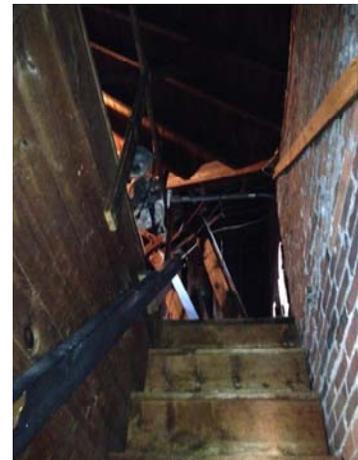
Bright areas indicate heat loss from the projection room into the attic. The warm duct and fan helped keep this cold attic a comfortable 50° one cold, clear, night when it was 27° outside. As does this charming staircase with unsealed and un-insulated door.

Two of the few “low hanging fruit” opportunities involves creating an easily opened thermodome (R20 insulated box with tight fitting, weighted seal) for the top of the steps leading to the attic and air sealing around the exhaust fan assembly near the belfry. In fact, this warm air in winter could possibly be ducted back into the ceiling of the large theatre. In the summer, an alternate duct (Y connection with damper) should vent this warm, humid, air to the outside.

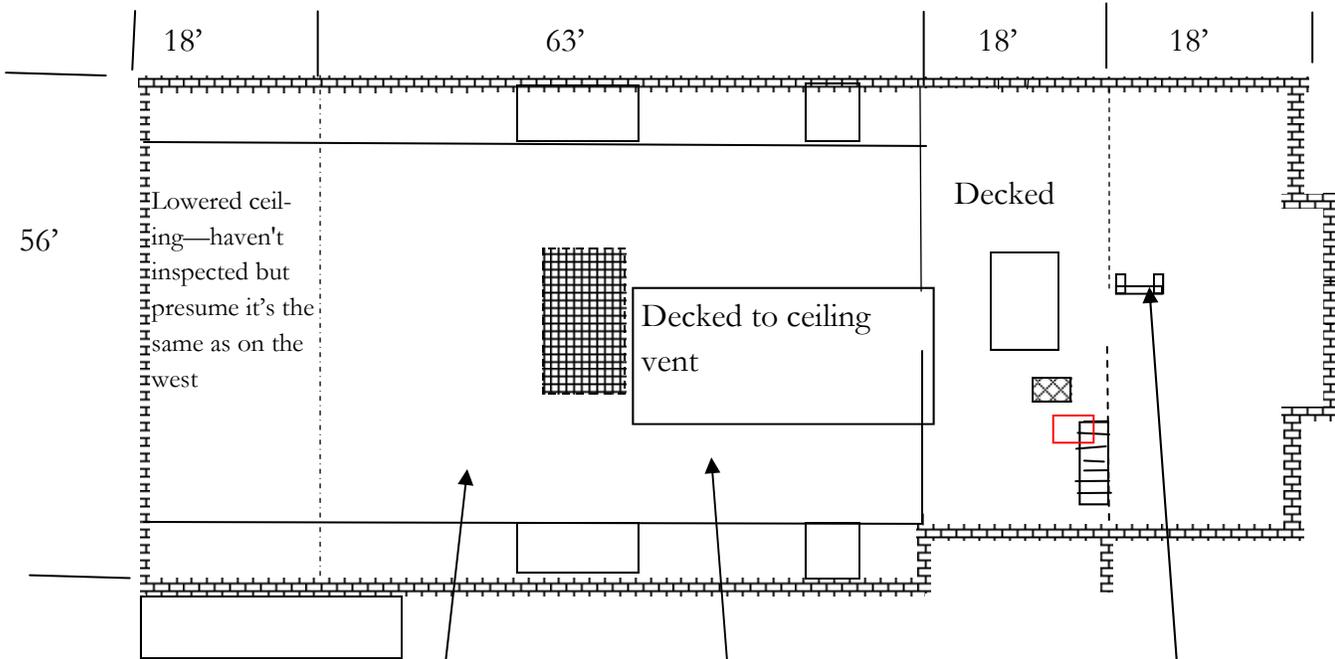
Slopes and gables MOSTLY void of insulation - 6" or less on flats

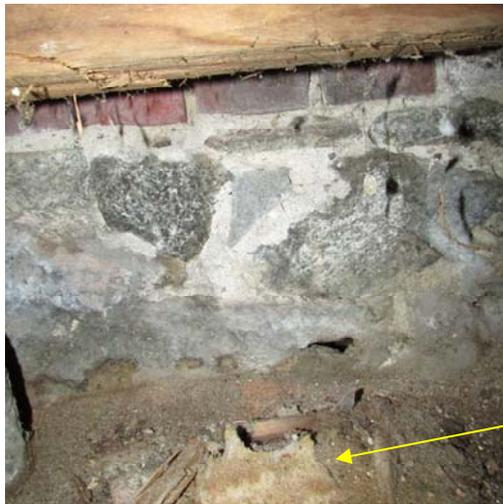
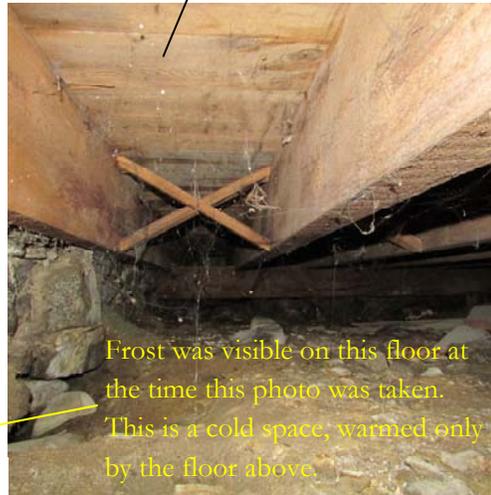
This the view below the floor from the corner opening to the left of the woman's' restroom door.

Larger access hatch in a 4' hallway, under a carpet, in front of the door to the Planning offices. John says its much better viewing and along the sewer pipe trench.

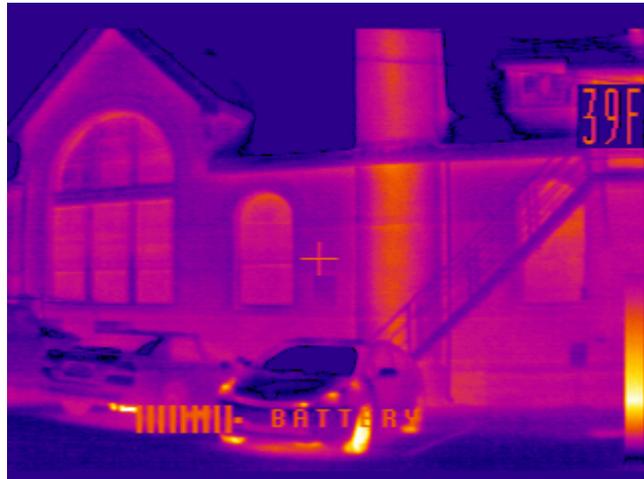
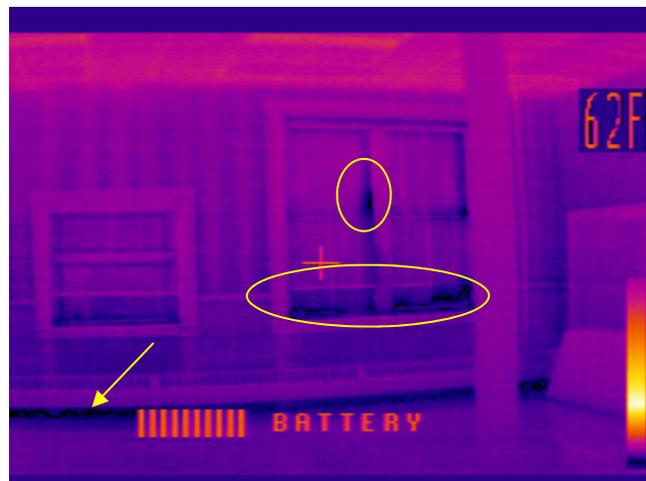
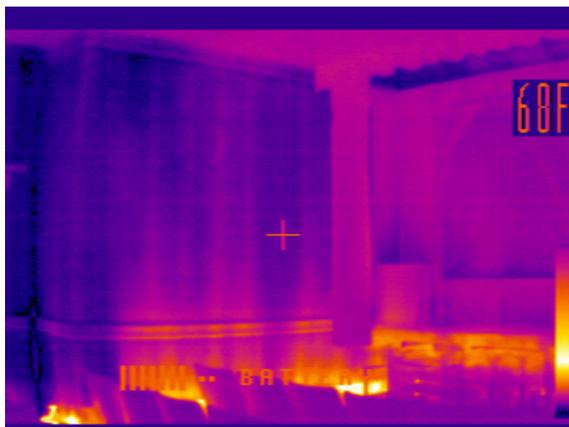
Circled areas indicate air infiltration or ‘wind washing’ causing discomfort and responsible for considerable fuel usage.

Steam pipe along the wall near the floor radiate Btu’s as well as via convection as cooler air from the floor is warmed then rises because it is lighter, and warms the air while warming things and people in visual contact with the source.

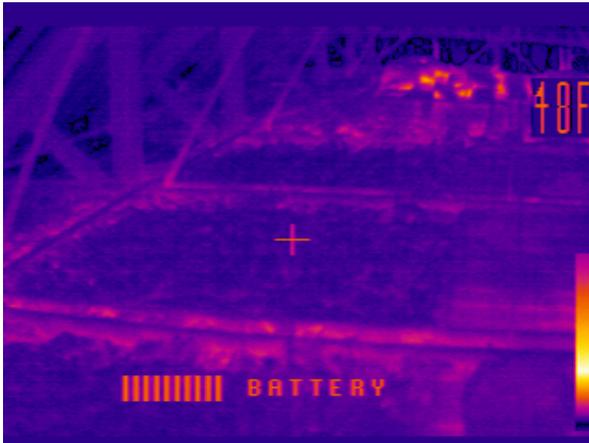
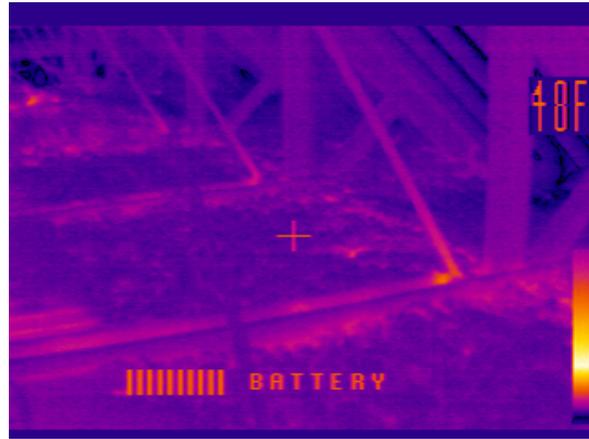
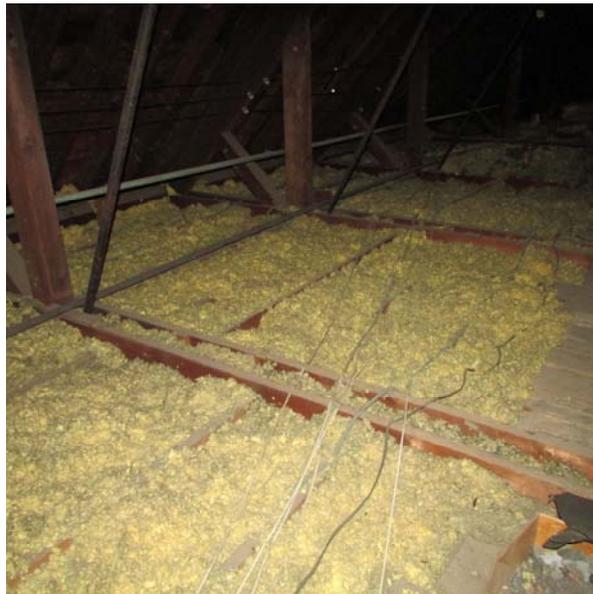
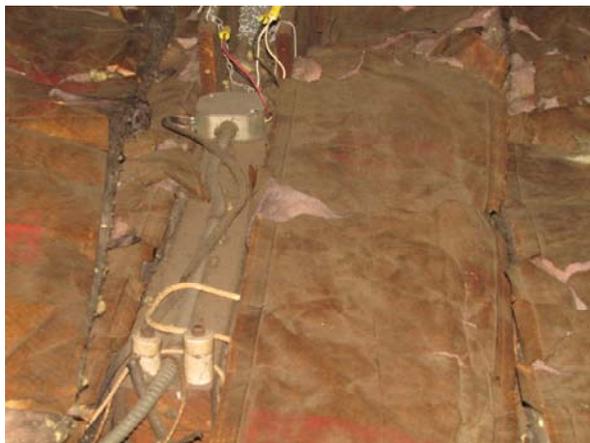
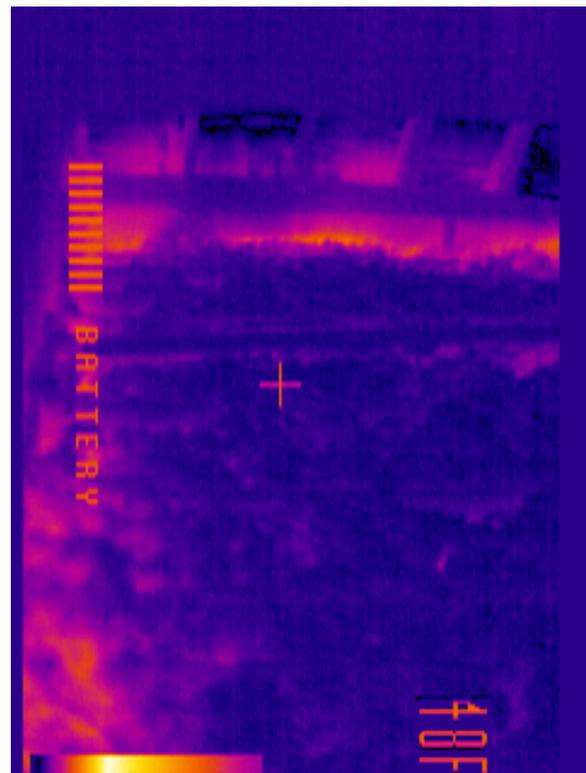
### Main Attic Floor

Four to six inches loose fill insulation material including rock wool and older fiberglass rest on the lathe and plaster ceiling but do not cover framing nor stop air from rising through framing gaps. Fiberglass batts over center vent, which is opened in summer, allow considerable heat loss in winter.

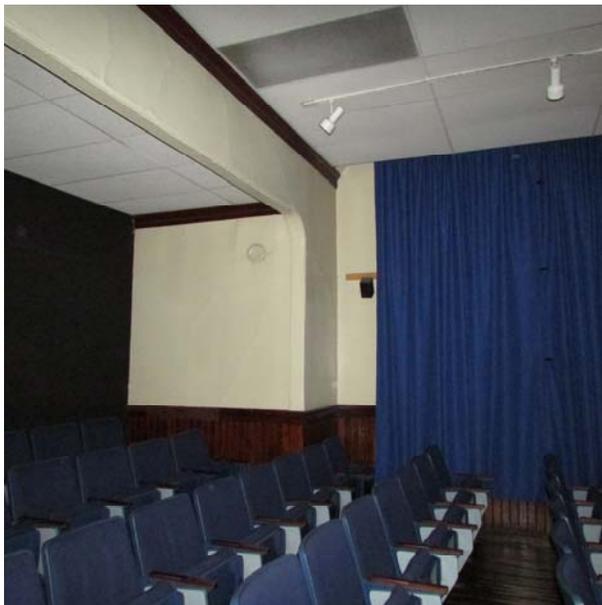
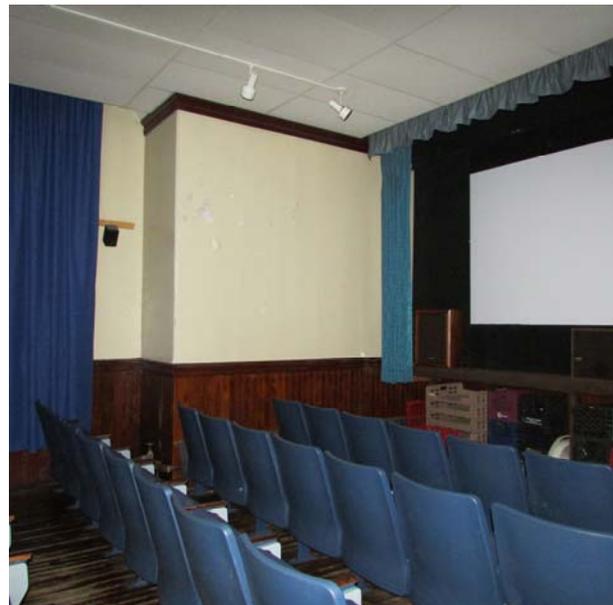
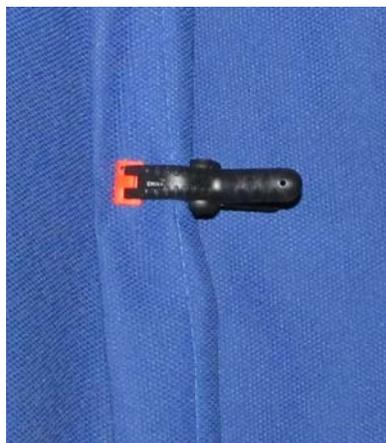
## *Small Theatre*

The small theatre has a large glazing to wall ratio, meaning that a high percentage of its wall surface area is in window glazing, though none of it useful for daylight, view, or air in the winter time. Insulated window panels would be the most cost effective way to improve a large surface area—especially on the windows behind the screen which I suspect haven't been seen in years!

This room is also one of the first which warrants mechanical ventilation based on a CO<sub>2</sub> reading of 2150ppm after 20-25 people watched a three hour (albeit suspenseful) movie. Over twice the CO<sub>2</sub> threshold for adding ventilation. It was also 78 degrees in the room by the end of the film as the room's temperature is controlled by the thermostat in the unoccupied, highly glazed and exposed Assessor's corner office stairs.

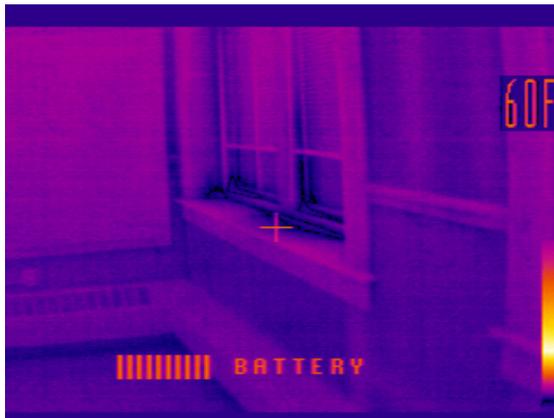
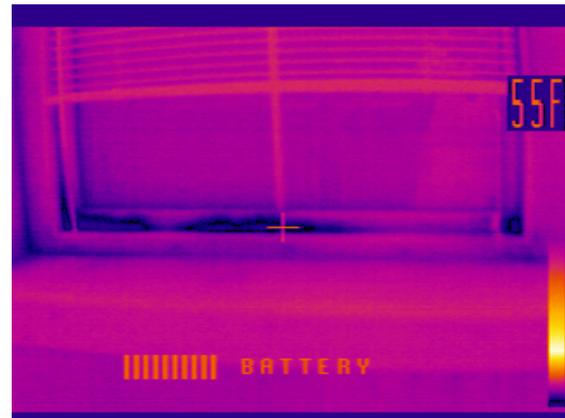
The two IR images above are classic examples of air leakage through both window sashes and rough openings. Professional weather-stripping can reduce the amount of air infiltration where the sash meets the sill.

1. 2 and 3. Weatherstrip all windows and doors. The windows in the Town Hall were significantly improved by adding dual glazing and replacing the weight and pulley system with a contained spring mechanism. However, there remains considerable leakage at the edges of the lower sashes in particular, especially where the bottom sash meets the sill. At relatively low cost per unit, gasket weather-stripping can be installed to reduce this air leakage. While a fairly simple task, it is worth hiring a skilled professional to assure the window will still be able to opened and close tightly and for longer lasting results. The same advice is true for all exterior doors.

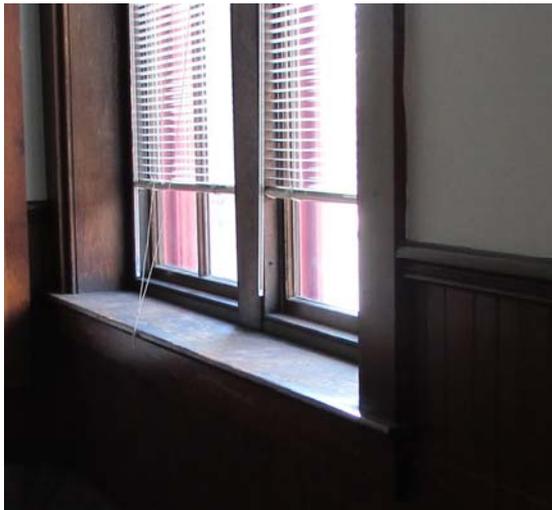
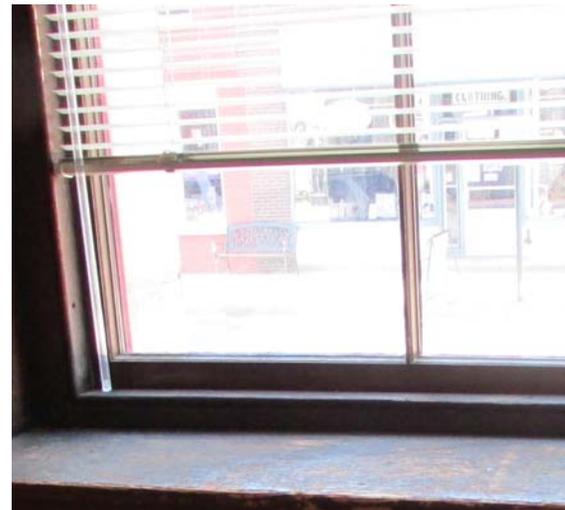
All the window sashes in the Town Hall have been lovingly restored by Window Master and a double “bi-glass” pane routed into the lites. All pulleys and weights have been removed and replaced with spring tape mechanisms and the weight chases sealed. This is a good way to improve the performance of a single pane window while retaining its historic character. The total window performance is still limited by the wood creating the divided lites and remaining air leakage.

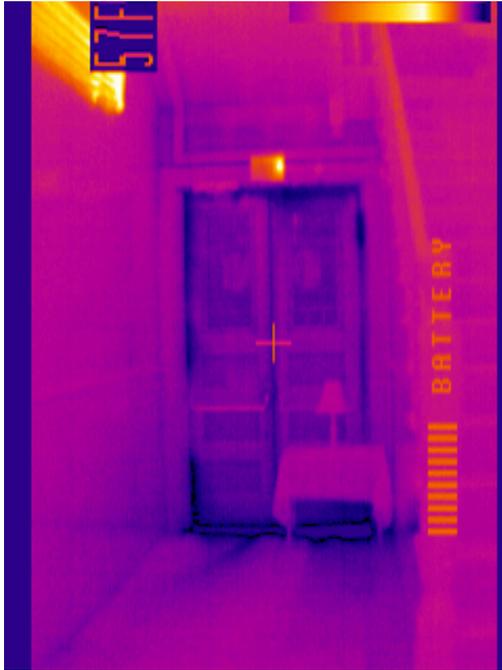
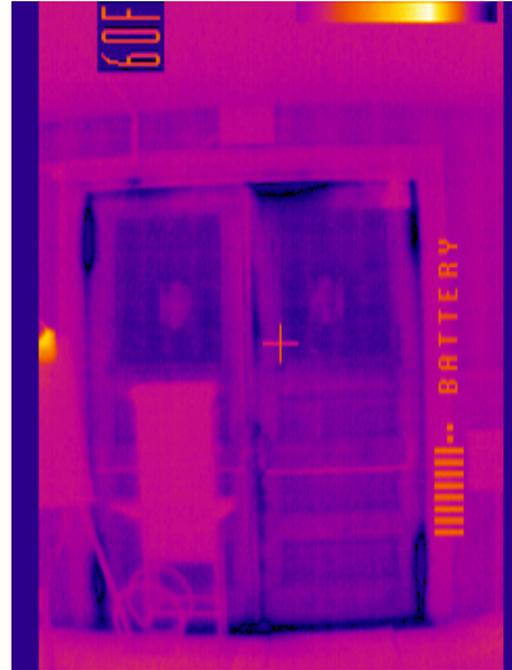
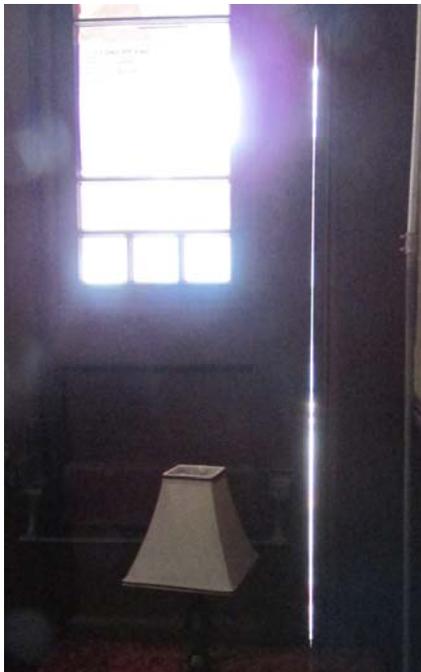
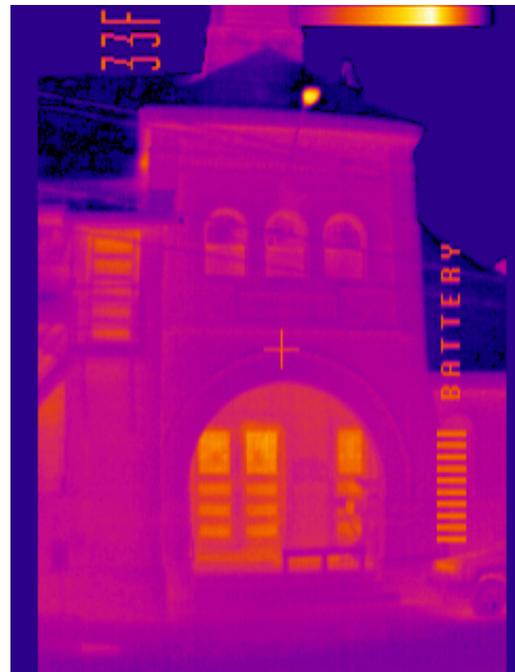
The Theatre doors have particularly large air gaps, but ALL exterior doors in the Town Hall would benefit from professional weather-stripping which should last many years and effectively stop air leakage while allowing the door to still open and close!

Mentioned and budgeted separately, but the door to the attic and the 'hatch' over the Large Theatre Ceiling Vent are technically also considered exterior door openings.

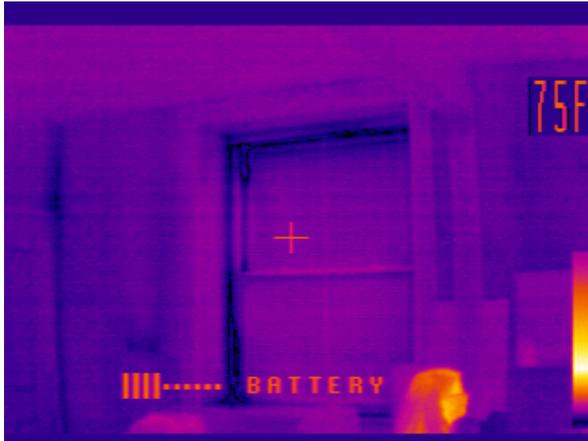
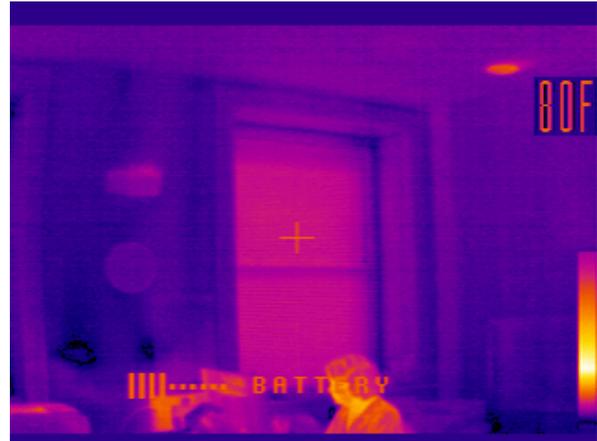
### Selectmen's Office

The renovations completed from the 1998 design included 2x4 framing, offset from the wall about 7", as shown in the images below, all taken from above the suspended ceiling in the restrooms. The IR images above suggest that the thermal performance is relatively poor, as would be expected from 3.5" batts without an air barrier on all six sides and not installed according to the manufacturer's recommendations. Better than nothing, true—but a better thermal barrier would yield far better results. In addition, any warm moist air that migrated through the air gaps to the cold foundation wall will at some point condense. Removing the batts above the suspended ceiling and spraying 3" SPF from the ceiling (or floor framing above) down the wall as far as possible is recommended to effect a continuous air, moisture, and thermal barrier.

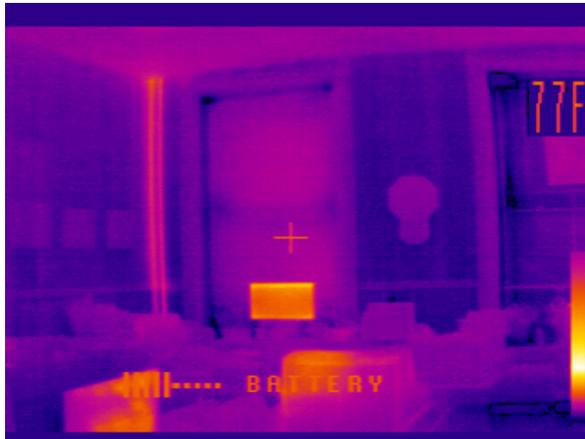
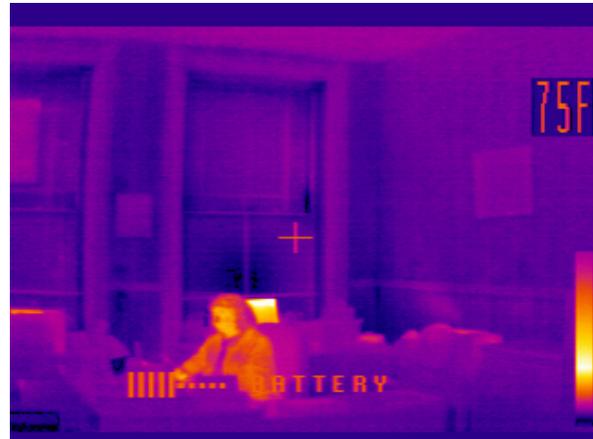
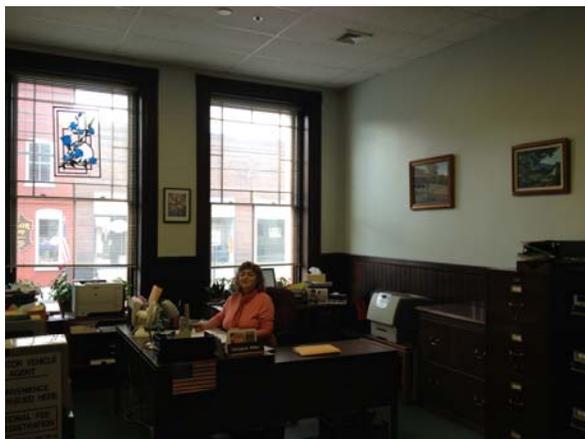
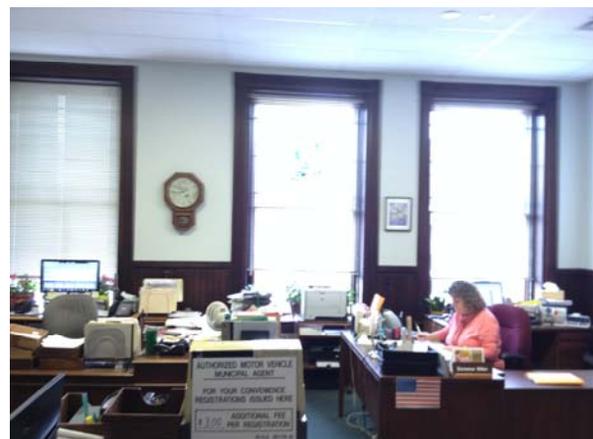
## *Clerk's Office*

The walls of the Clerk's Office appear to be uninsulated and remain an opportunity for reducing heat loss and improving comfort in winter and summer to a lesser degree. The same insulation strategy recommended for the Selectmen's Office is recommended here, though in this case, removing the wall surface and wainscoting for a comprehensive wall insulation project is preferred.

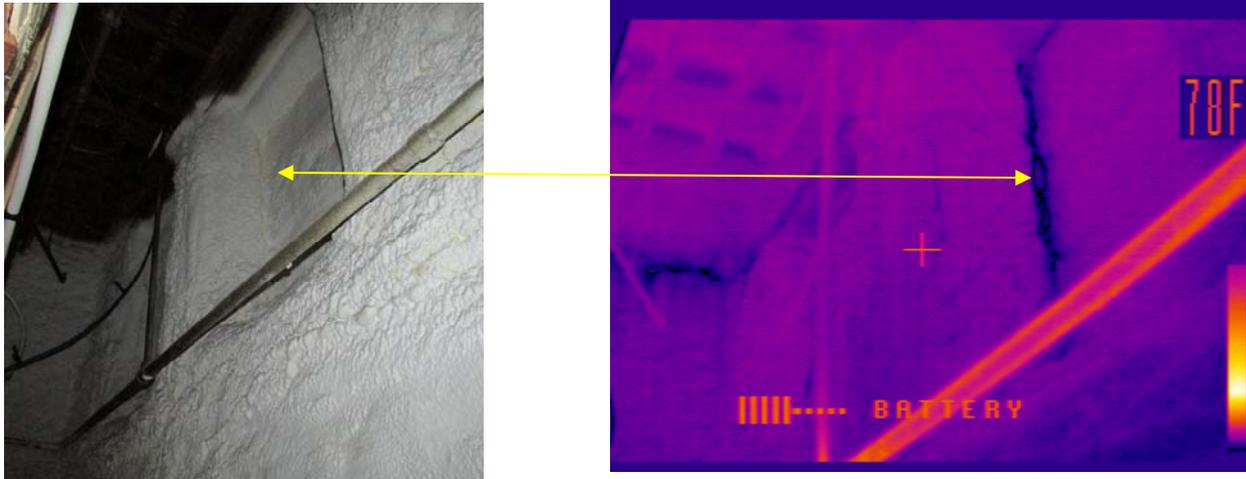
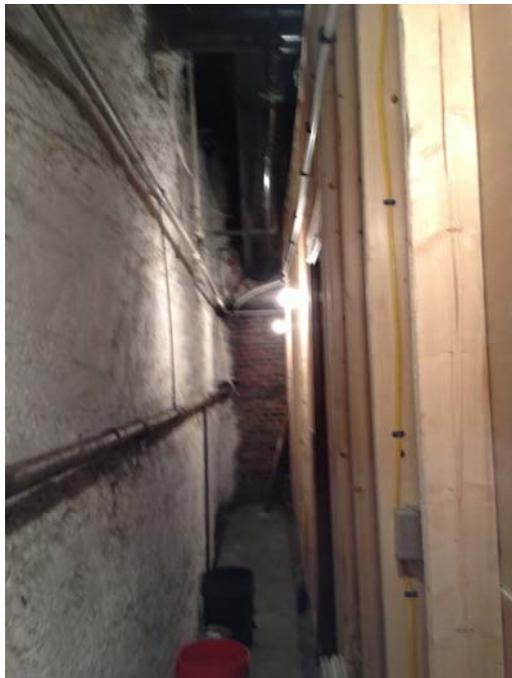
### *File Room, Kitchen, and Women's Restroom*

Overall an excellent improvement to this below grade foundation wall—and recommended for the rest of the foundation wall as possible. There does appear to be air leakage in through a crack at the window opening, hence the adage: “Eye tight is not necessarily air tight.”

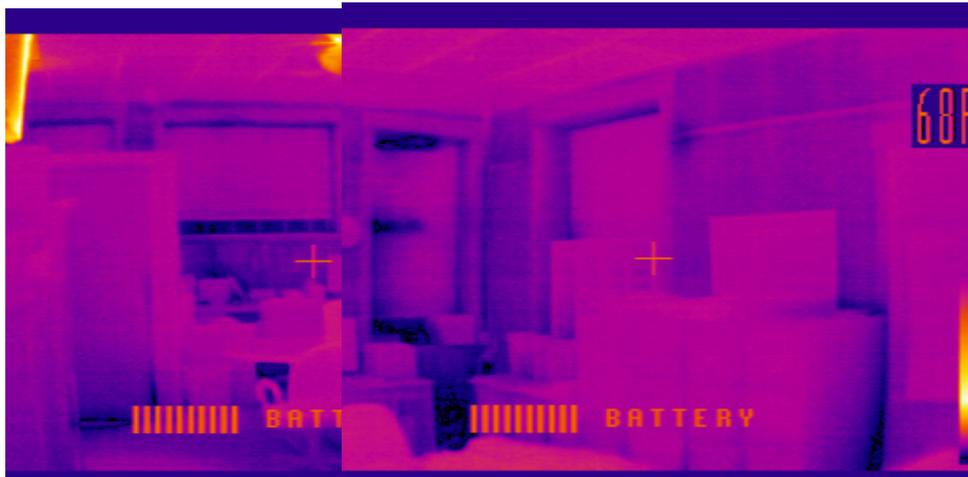
## *Tax Assessor, Planning, and Building Inspector's Office*

The coldest and least comfortable area in the building, this area suffers from more doors, windows, and exposed exterior walls than any other office—compounded by the radiators and pipes located at the ceiling which offers less benefit—especially as high infiltration rates force the warmer air to the ceiling.

These office areas constitute the bulk of the Tier II improvements but only make sense during a comprehensive renovation project—the design of which is outside my expertise and scope of this study.

I would also suggest that adding a ductless air source, VRF, mini split heat pump would provide extremely efficient cooling and some heating and an residential ERV unit would provide balanced ventilation with energy recovery. These suggestions would be part of the HVAC design but offered here to reflect the appropriateness of these 21st century technologies for this office area.

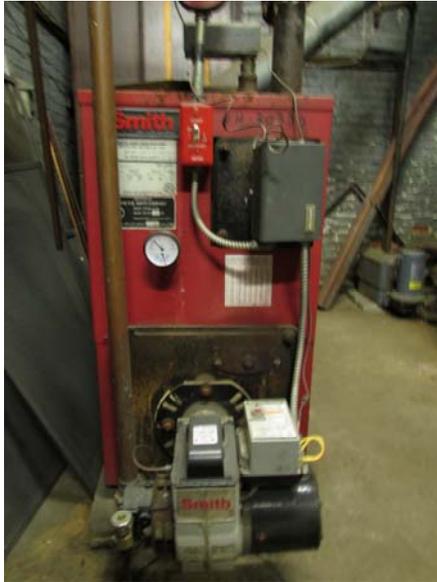
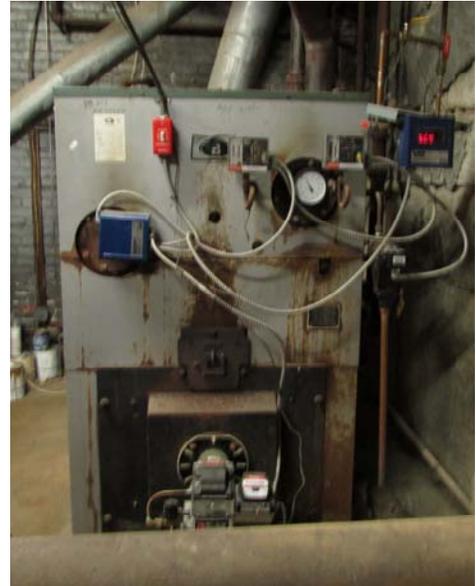
These two boilers and distribution systems are operating about as efficiently as is possible. If anyone could squeeze greater efficiency or tweak the system to perform better, it would be Adrian Pinney out of Keene.

Completing even Tier Two envelope upgrades will reduce fuel costs and improve comfort, and could buy more time with the existing equipment—and would not an unreasonable decision.

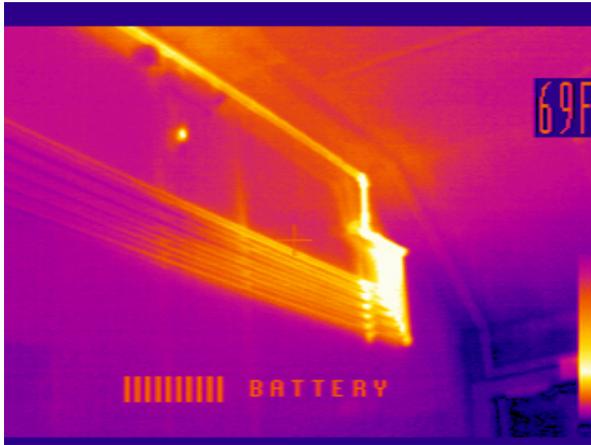
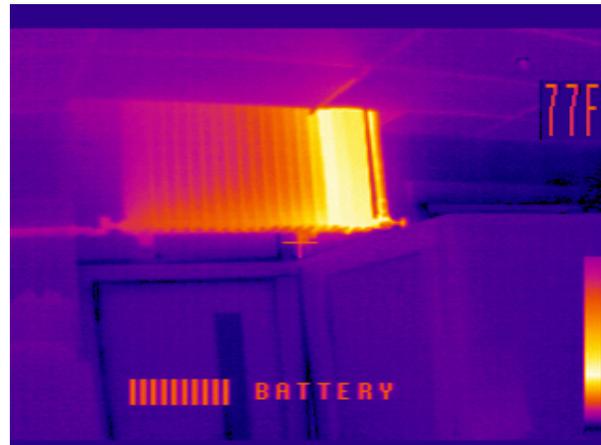
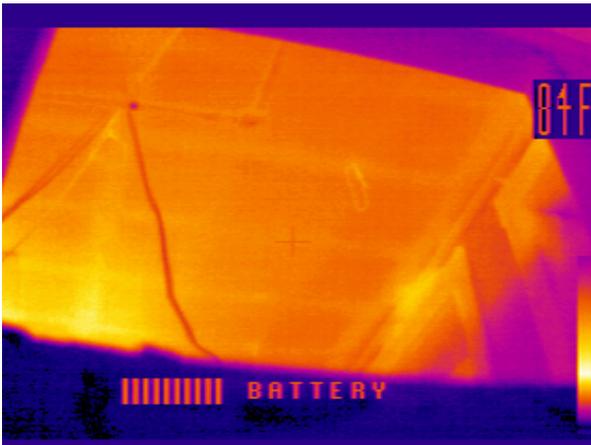
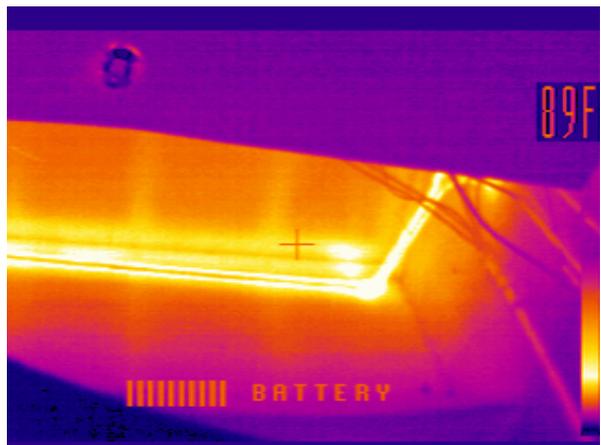
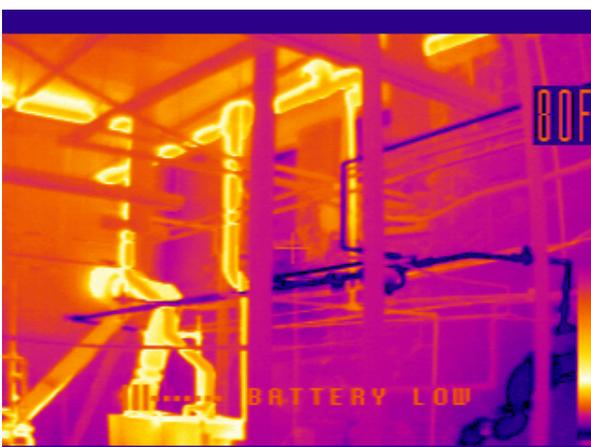
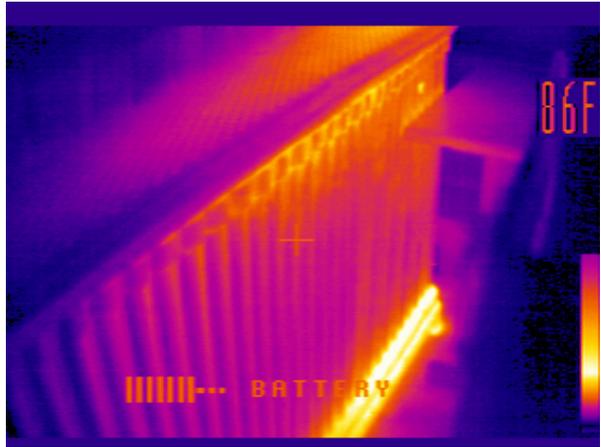
Comfort will likely always be an issue with the way the existing distribution is set up. Envelope improvements will certainly help prevent the need for wearing a coat in the office, but a lack of thermostatic control and uneven heating is a condition of many steam systems.

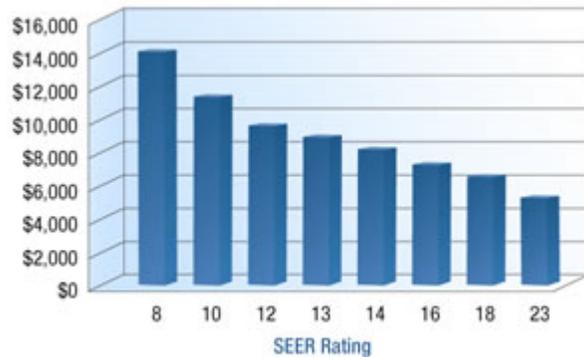
Life Cycle Air Conditioning Operating Cost

Based on performance of one 3 ton air conditioning unit operating for 2100 cooling hours at \$0.11/kWh. Actual costs may vary depending on climate conditions, energy rates, and patterns on usage

Based on current usage estimates, cooling the Town offices may cost between \$300-\$400 a year so replacement for more efficient units is not recommended at this time. However, when these units have outlived their service life, replacing them with high efficiency heat pumps (SEER 18 or better) is strongly recommended.

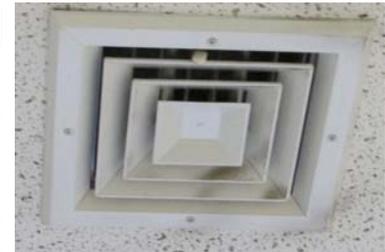
Of greater concern is the fact that the duct are not sealed and draw air from the boiler room which could become an air quality issue. Mastic sealing the ducts is a short term improvement, though this is another reason for replacing the existing boilers.

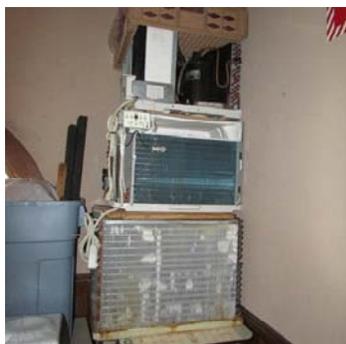
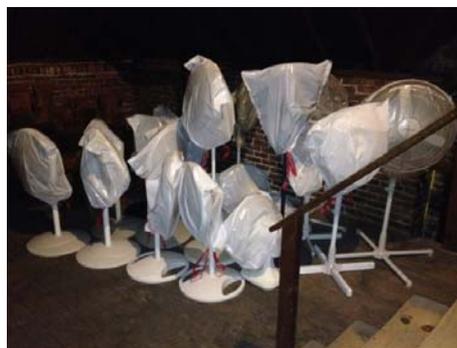
The cooling strategy for the Theatres include three window units (2) four year old two ton units and (1) 2 year old 1.5 ton unit) SEER ratings unknown but likely 8 or 9, an army of floor fans and the large vent opening in the Theatre ceiling with ceiling fan. Total summer cooling costs are estimated at \$500 a year.
